**INTERIM INSPECTION REPORT**

**OSTRAGER (DUCK) POND DAM**  
**DEEP INVENTORY NO. 06706**

**DEEPWOOD DRIVE**  
**HEBRON (AMSTON), CONNECTICUT**

**JANUARY 2024**

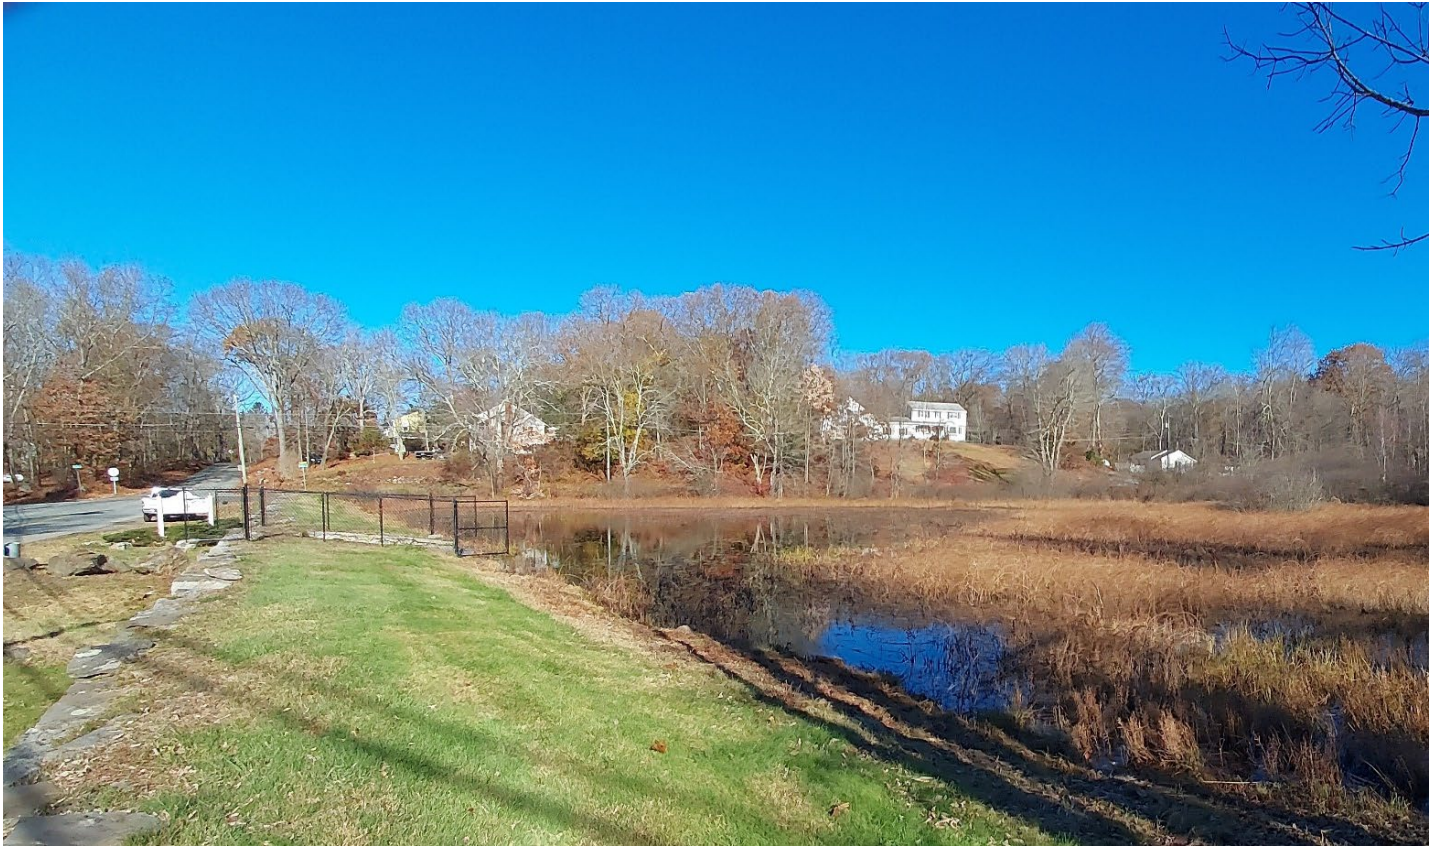
Photo 1 – An overall view of the dam from its left side abutment area. The top of the dam and grass area are well maintained.

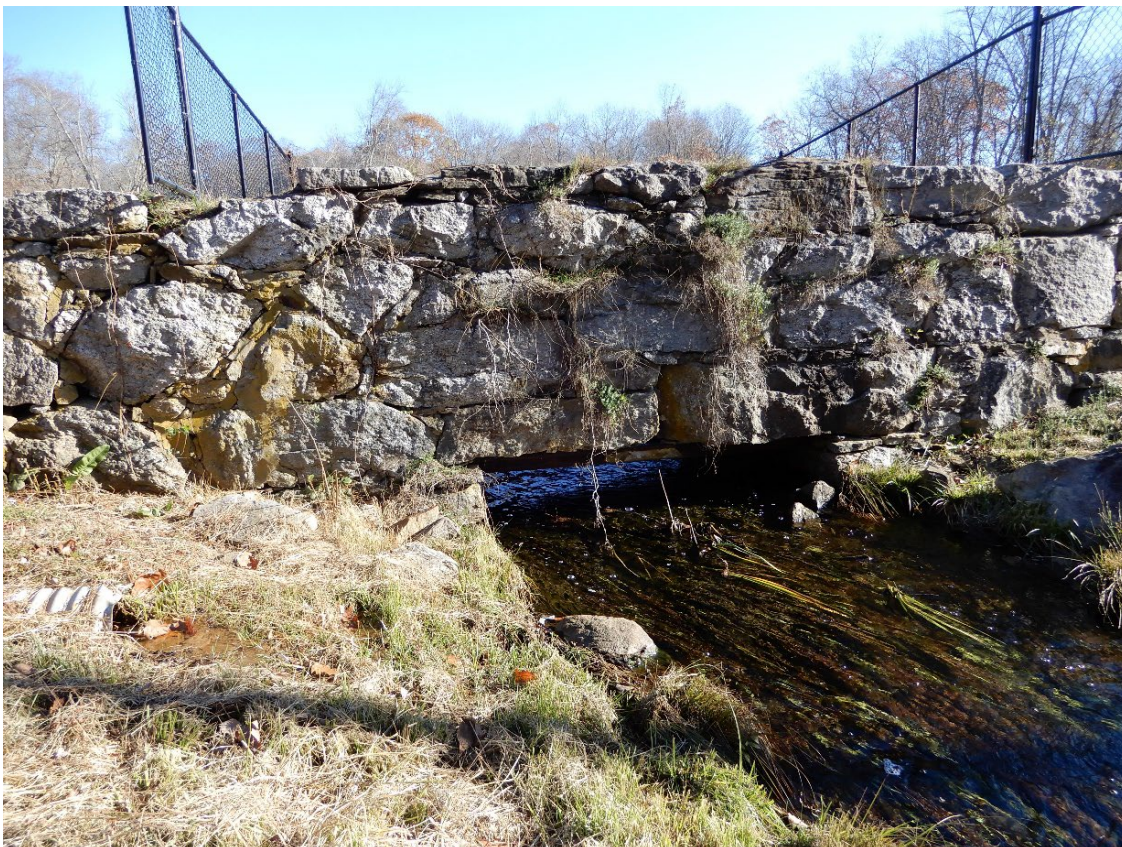
Photo 2 – The spillway area as seen from a downstream perspective.

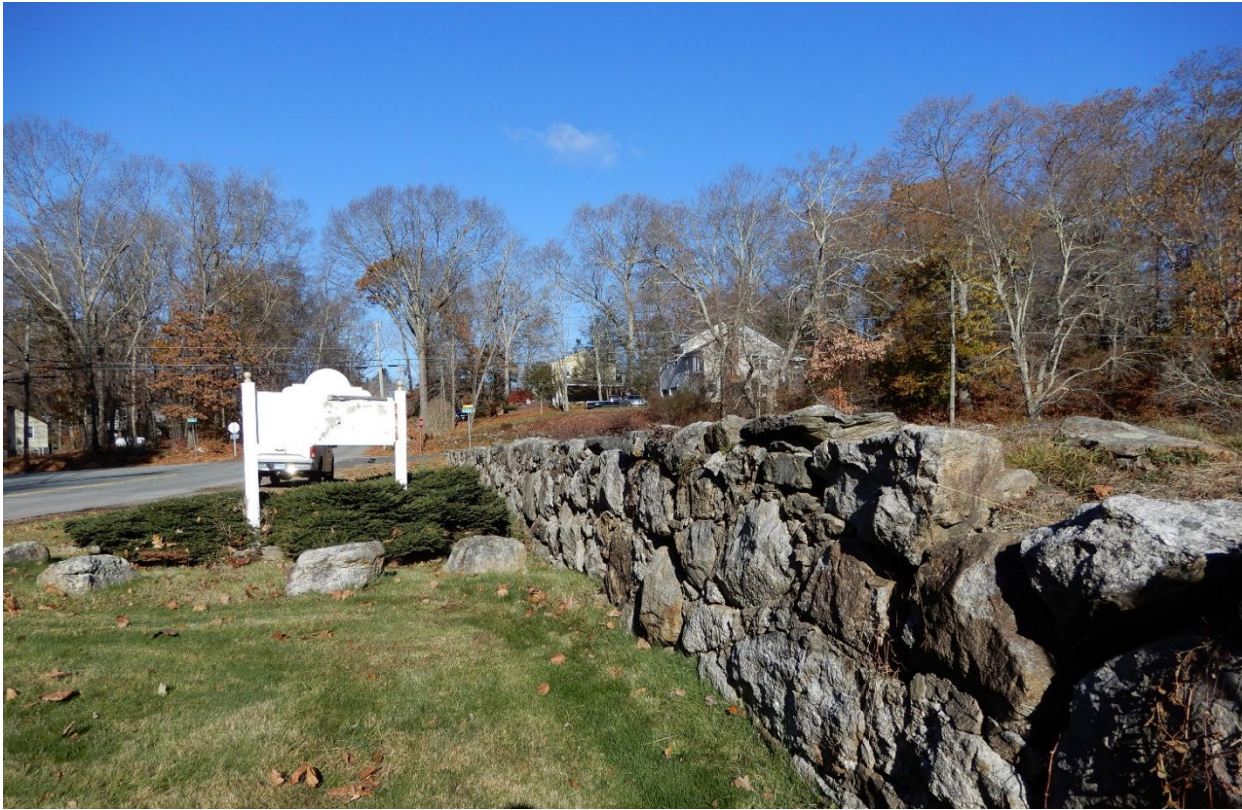
Photo 3 – A view of the right side downstream wall in stable condition, with a well maintained downstream grass area.

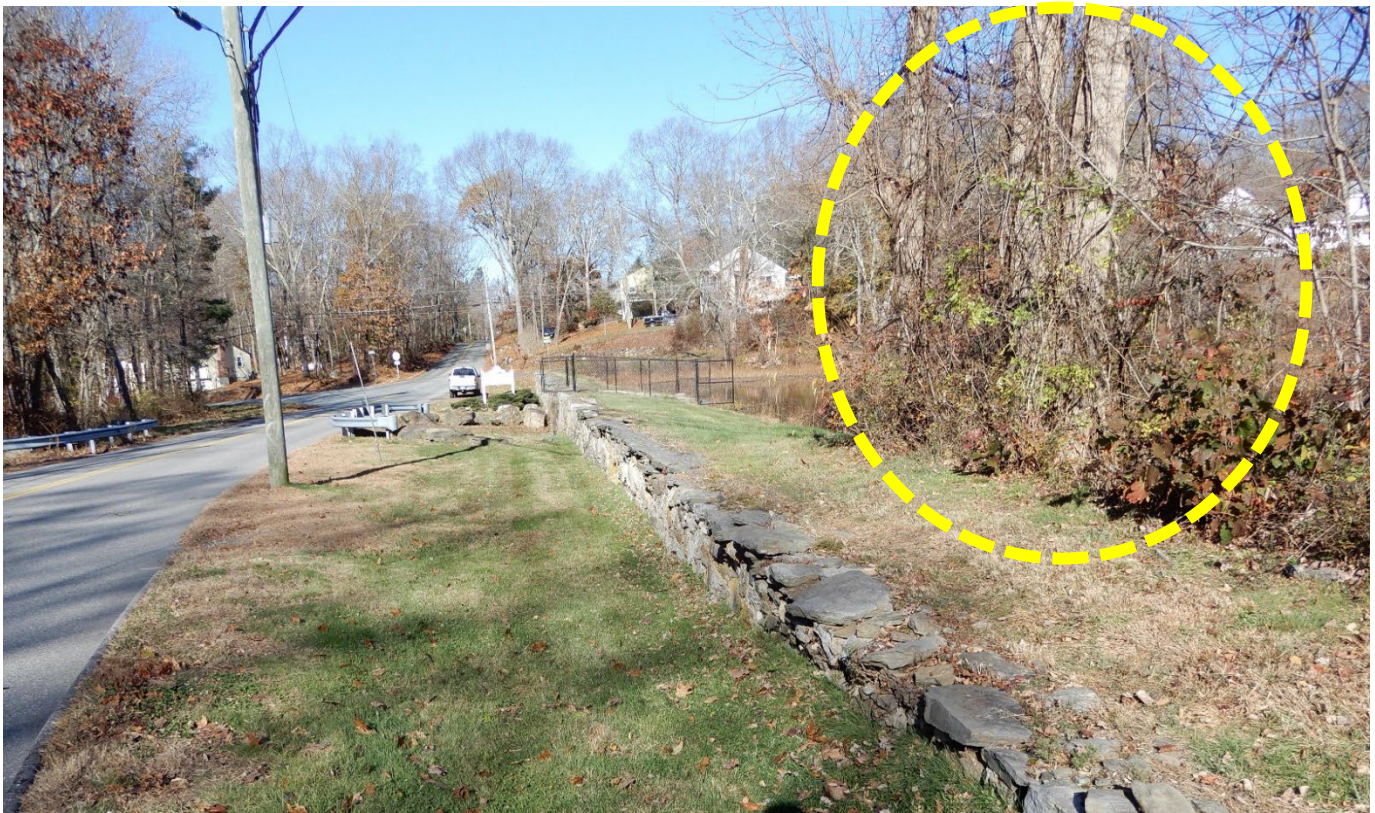
Photo 4 – The left downstream dam embankment, also in stable condition with a well maintained downstream toe area. Note, however, that there are several large trees along the upstream side of the dam, within the 25-foot limit area, which need to be removed.

Recommendations include the removal of trees and vegetation along the left side upstream shoreline of the dam embankment and the reconstruction of the spillway area of the dam. A plan was drawn up in 2008 for reconstruction of the spillway along the recommendations noted herein to address these issues; it has, however, never been implemented. Other options for the structure, again discussed in the 2017 report, included doing nothing; breaching the dam; or performing the repairs noted. Once the district association reviews the current findings, we would be pleased to discuss any questions or options related to the conditions described herein.

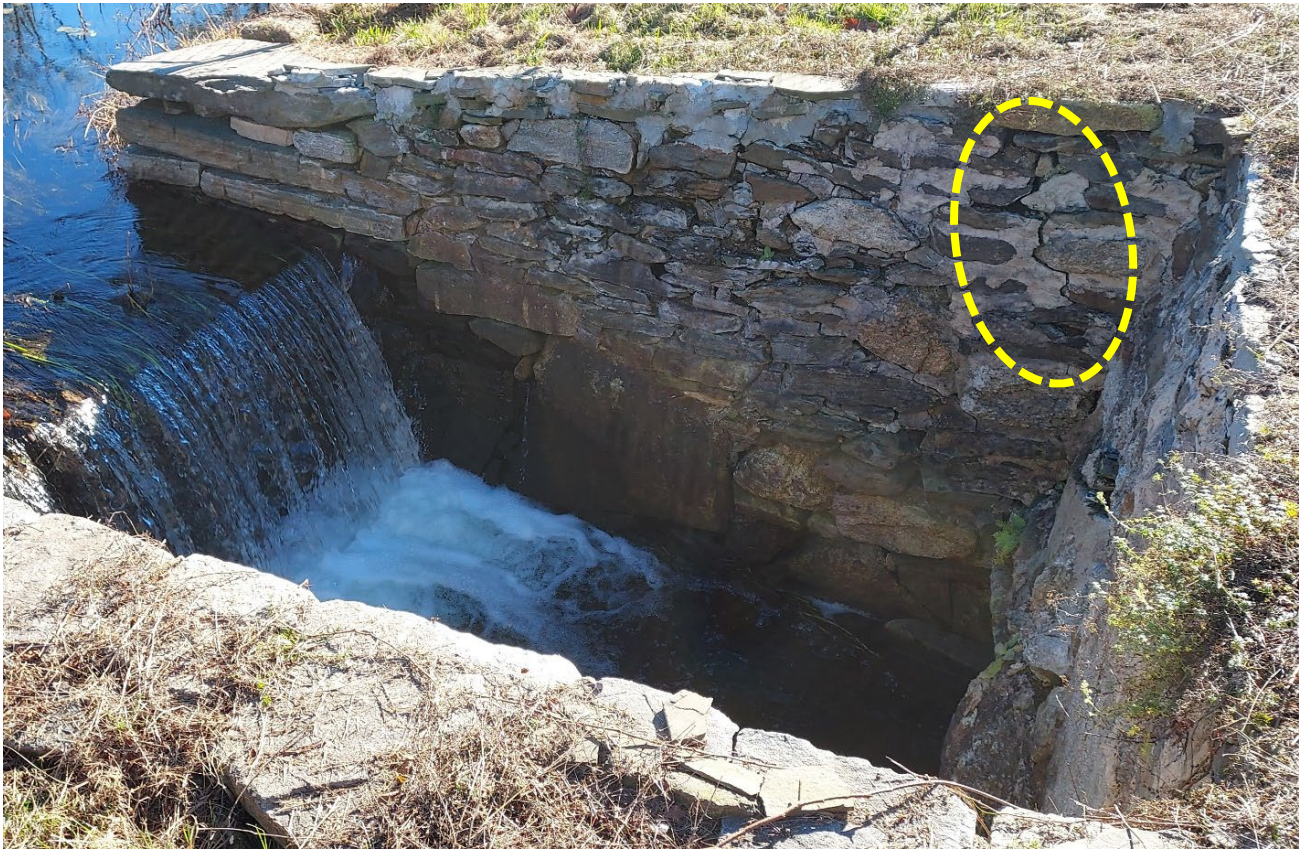
Photo 5 – The left side upstream training wall, highlighting a slightly diagonal vertical crack in the mortared masonry wall.

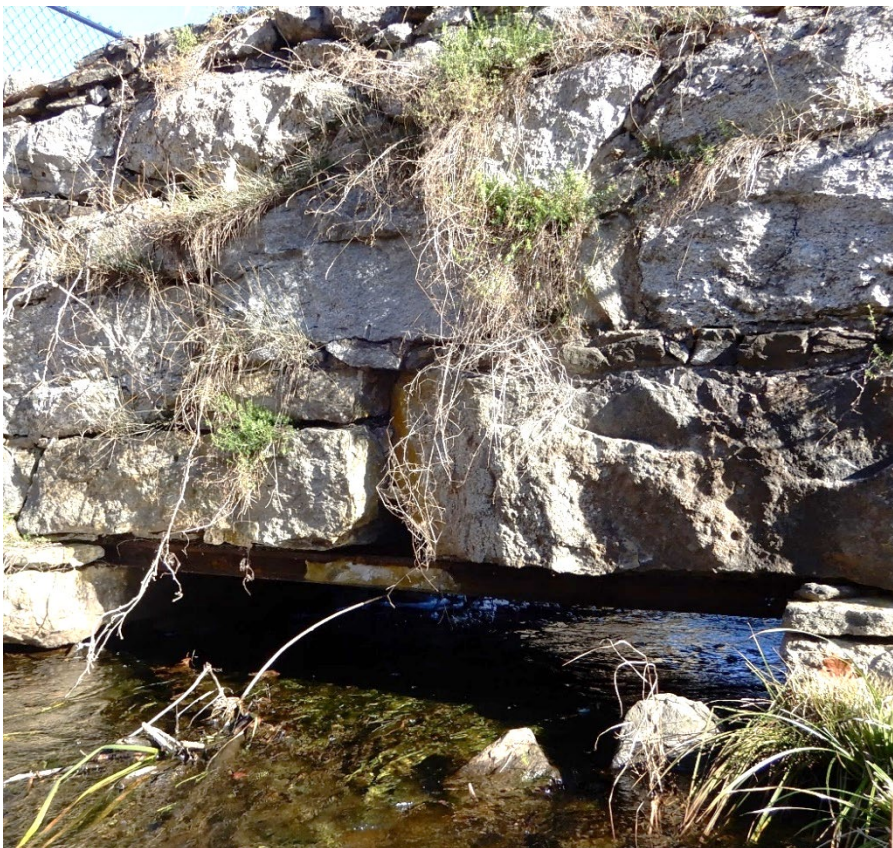
The area of greatest concern is the masonry section spanning across the immediate downstream channel. This entire section appears to be supported on three steel rails with support ends set into the base wall section on each side. The rails, which were noted as corroded in the previous 2017 report, have continued to deteriorate, now showing signs of advanced corrosion, particularly where most critical at the left and right side ends where the beams enter the masonry wall. Also, in photo comparisons taken over the last 15 years, there appears to be a slight downward bend in the center of the downstream rail and there is a complete loss of the web section on the right side upstream rail (see photo). There are two major issues with this overpass section: one is the small opening between the stream bed and the base of the wall which could lead to clogging of the opening from debris and organic

matter emanating from the upstream marsh area; and the second a potential collapse of the wall over the outlet area, again clogging the opening. In the prior report it was pointed out that should either of these situations occur during a severe storm situation, it could lead to overtopping of the entire dam. As it stands currently, this could also occur in the case of high flows due to the limited flow capacity of the small spillway weir section (see previous report for discussion).

Photo 6 – A closeup of the downstream face, noting the corroded section of supporting rail below the open gap at the base of the supported wall.

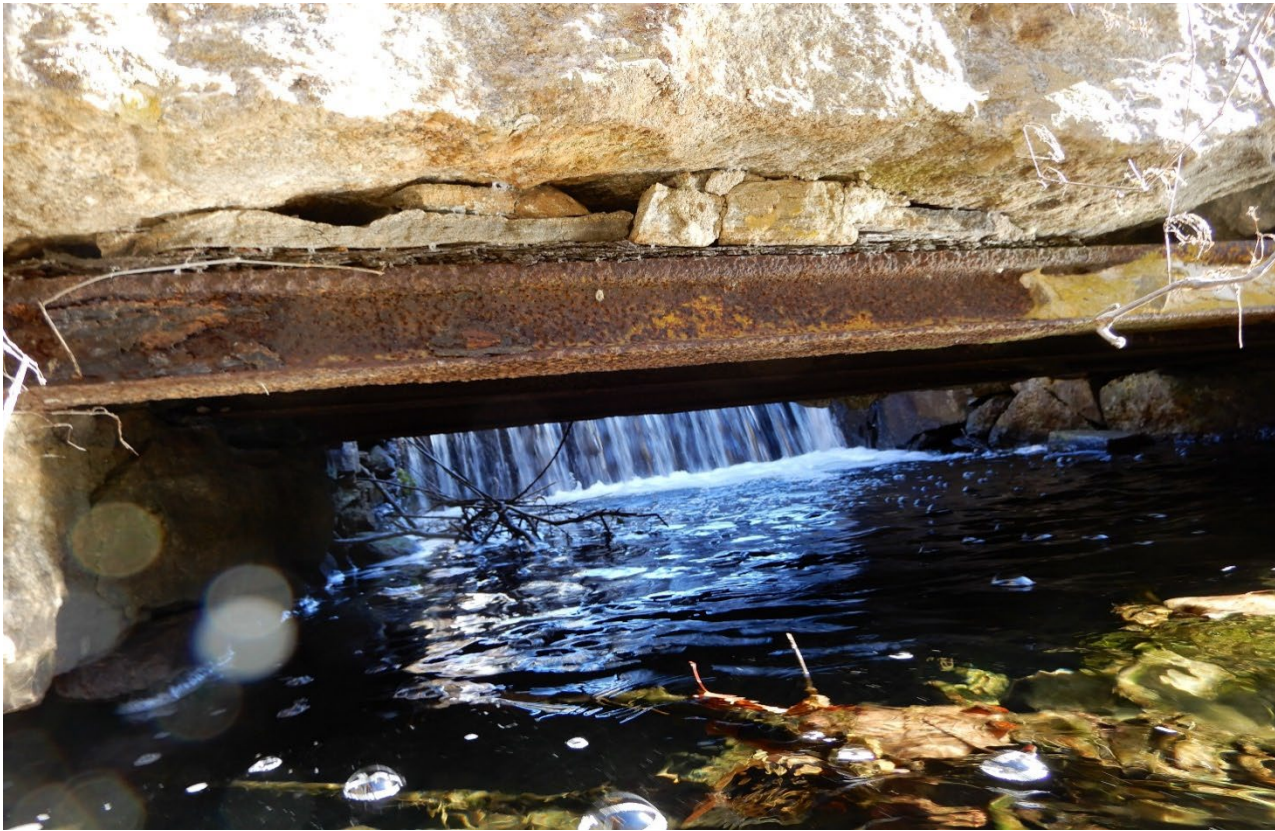
Photo 7 – A closeup of the right side downstream rail section, showing advanced corrosion and loss of section at the supporting end at the left side of the photo. Other underlying rail supports, although difficult to photograph, are in similar condition.

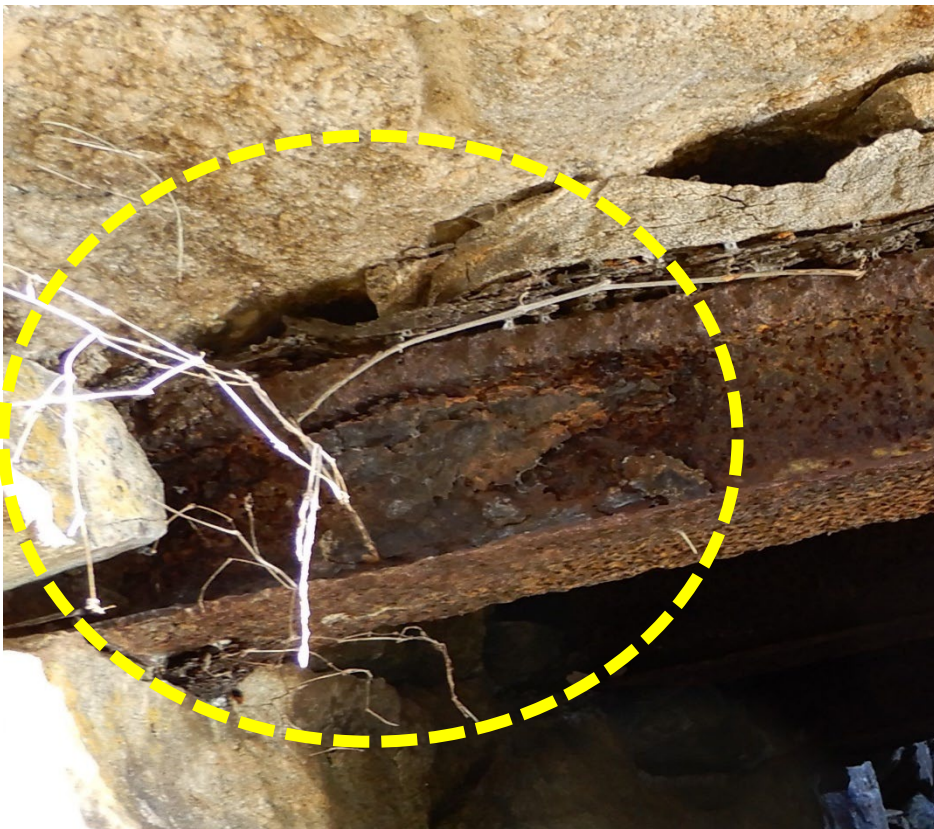
Photo 8 – A further closeup of the rail support section in the above photo.

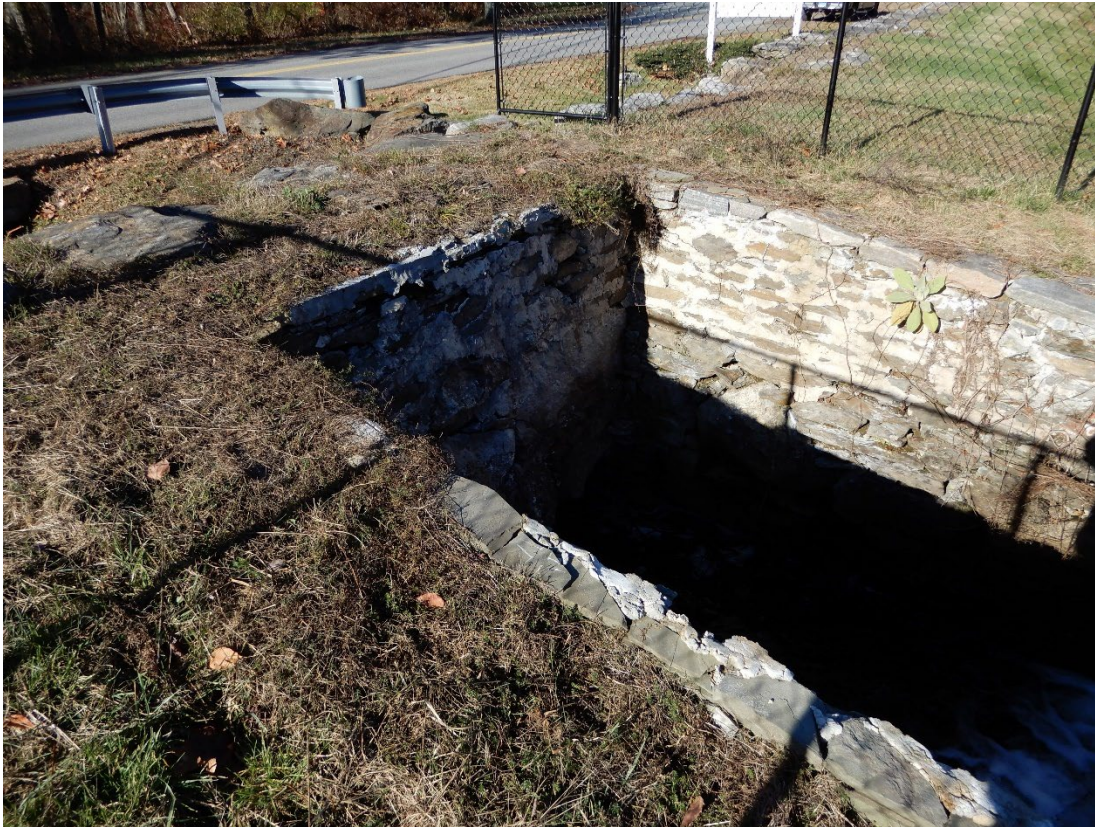
Photo 9 – The right side spillway training wall, the upper mortared section of which is in good condition.

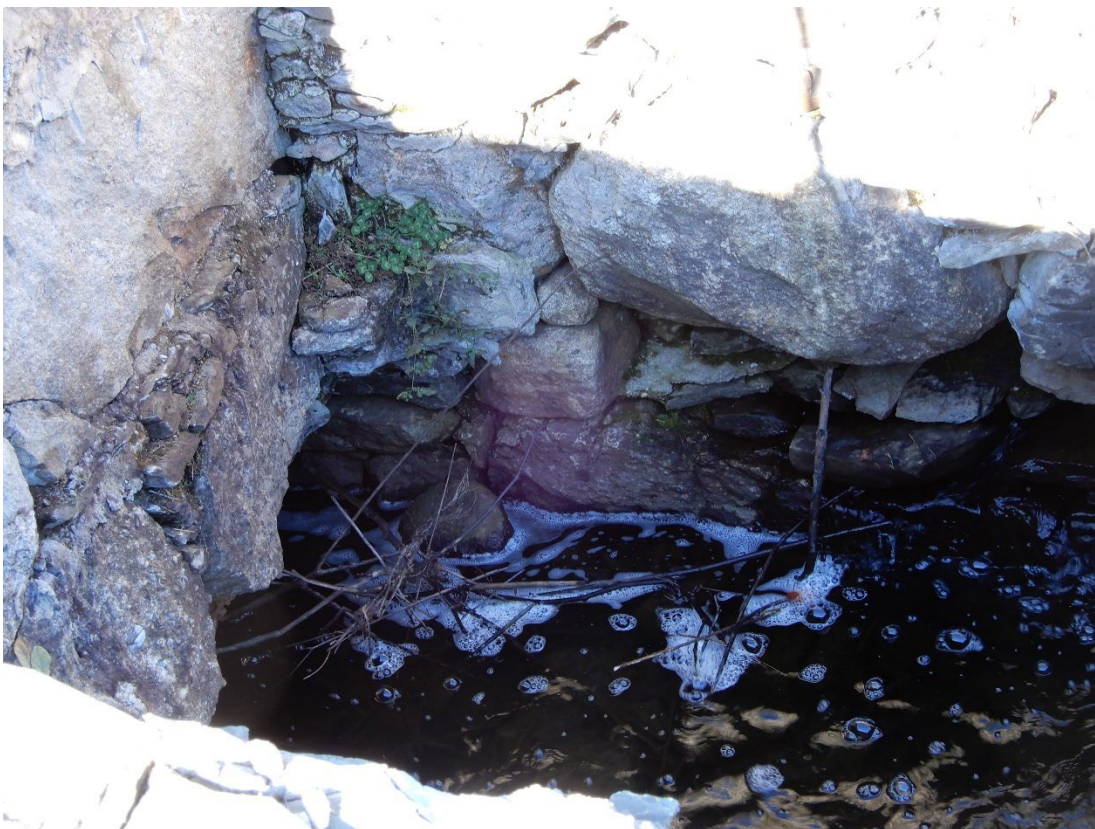
Photo 10 – The lower portion of the same right side wall section, dry stacked with void spaces and apparently missing chinking stone.

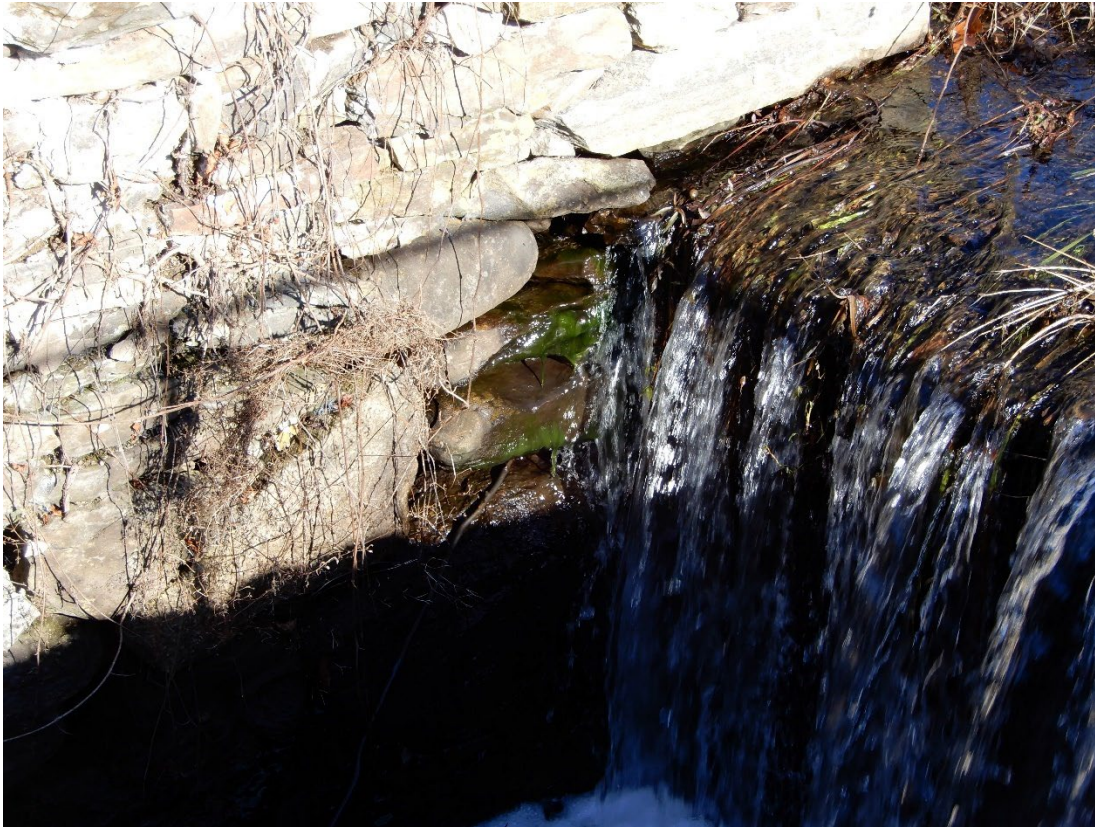
Photo 11 – Another view of the same right side wall, showing seepage through the open stone area directly adjacent to the spillway weir section.

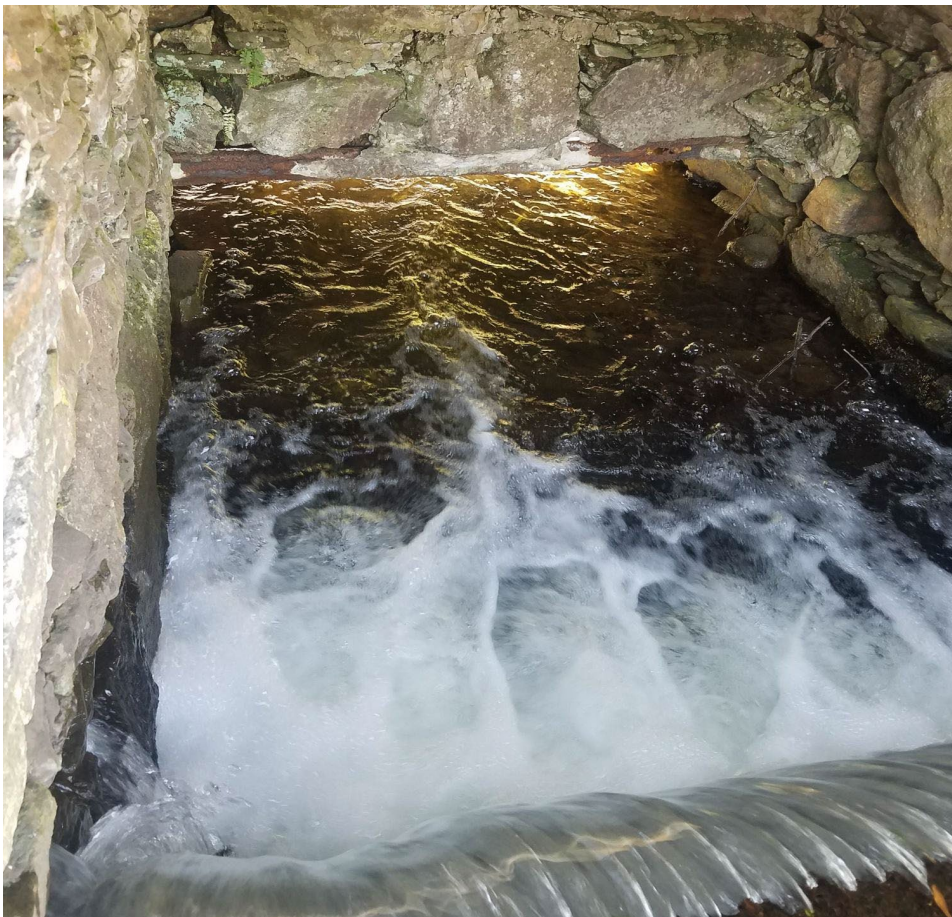
Photo 12 – An upstream view of the stone masonry crossover section below the spillway, showing the corroded upstream support rail.

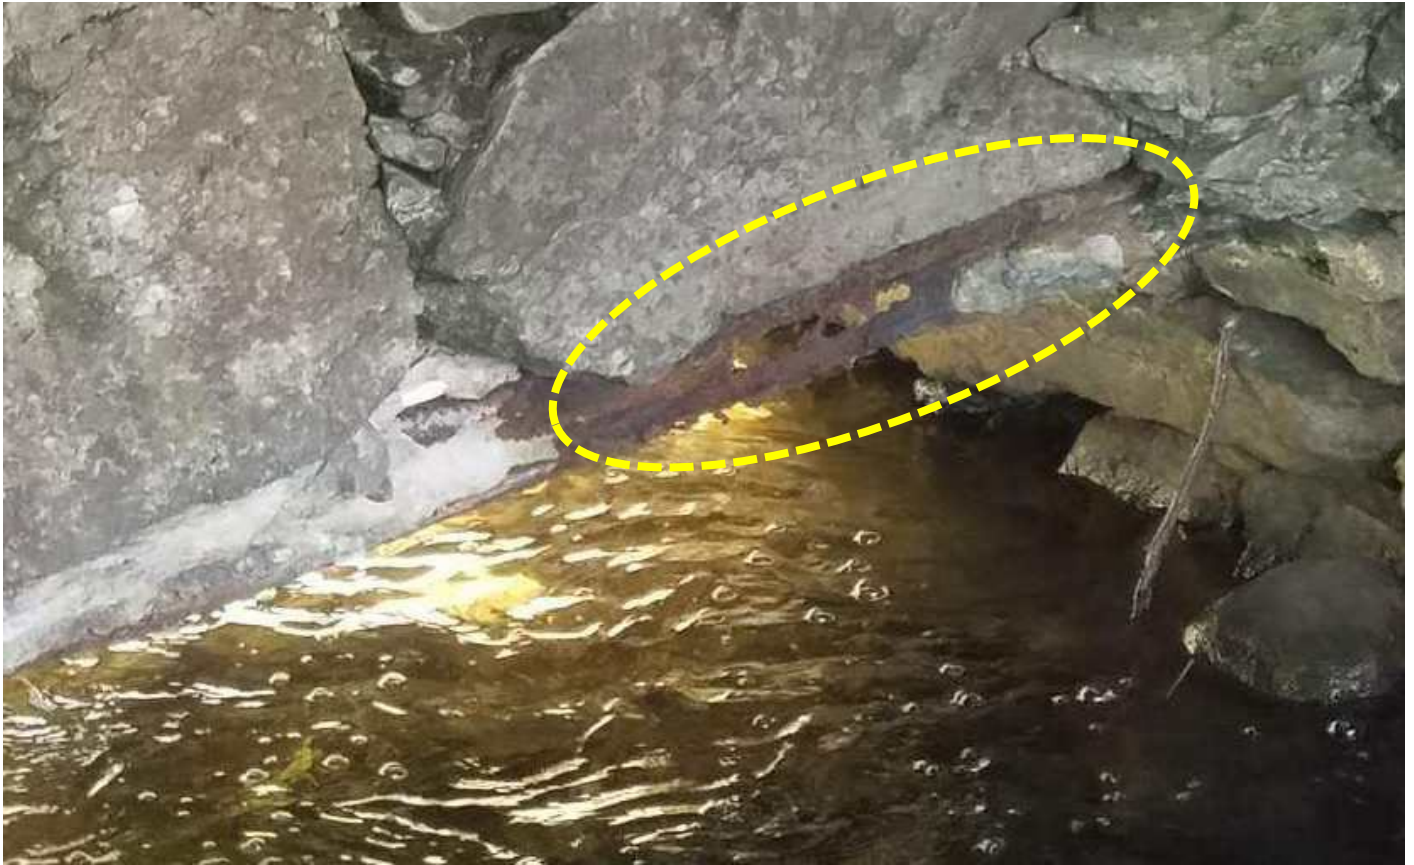
Photo 13 – A closeup of the upstream support rail showing a complete loss of the rail's web section at its right side support area. While the thickness of these sections varies and the origin of the rails is unknown, a median value should be a thickness of approximately  $\frac{3}{4}$  of an inch.
